APPENDIX B

Site Reconnaissance

Date: Thursday 28 June 2007
Staff: Brian Myller (Waterstone), Richard Taylor (Waterstone)
Project: Proposed FBI Denver Division Office Building
Site Address: Former Stapleton Airport (East of 7805 East 35th Avenue)
Site Manager: n/a
Access Limitations: Site was not accessible to due active asbestos remediation. Site reconnaissance was limited to visual inspection from the western Site boundary and from the nearest accessible locations in the north, east and south. The eastern part of the site was not clearly visible to us.

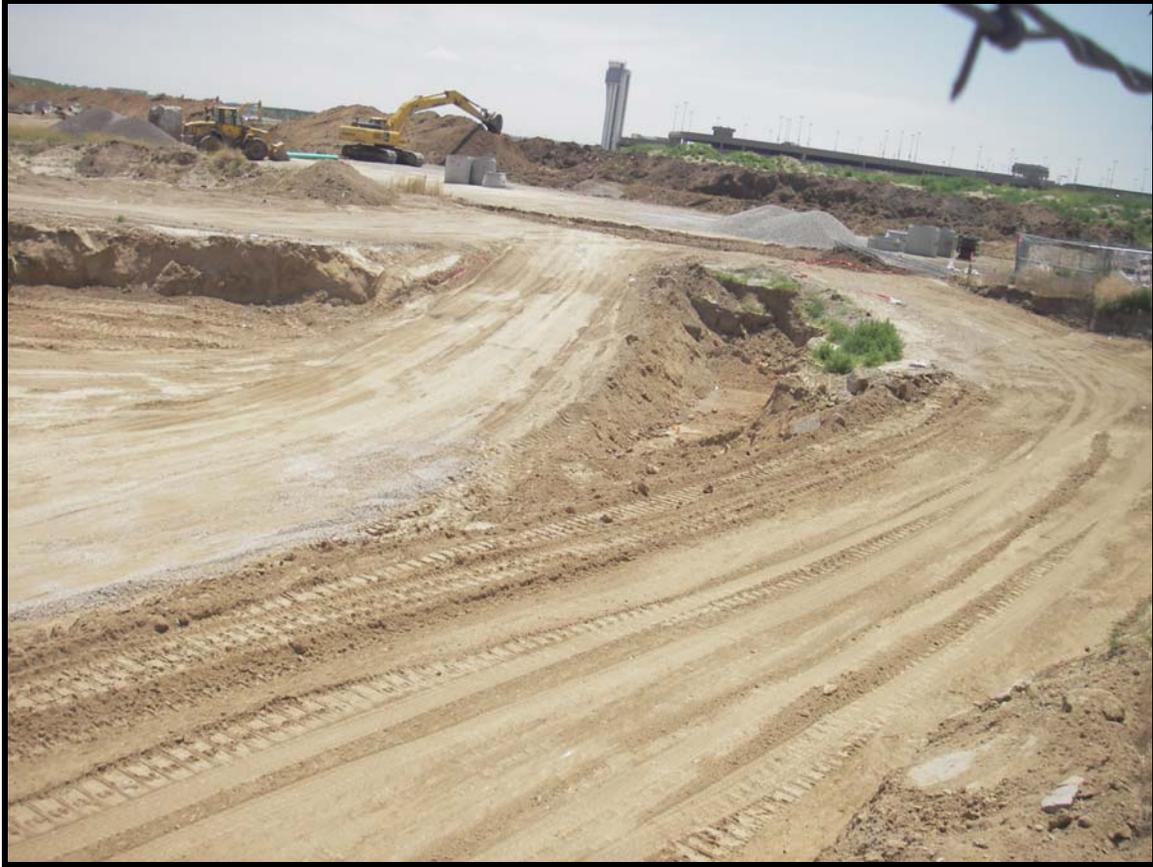
#1

Looking south-east from the south-west corner corner of the Site.

The photograph shows the laying of storm drains along East 35th Avenue and the south-west corner vehicular access to the Site. The Site is in general highly disturbed with very little vegetation growing.

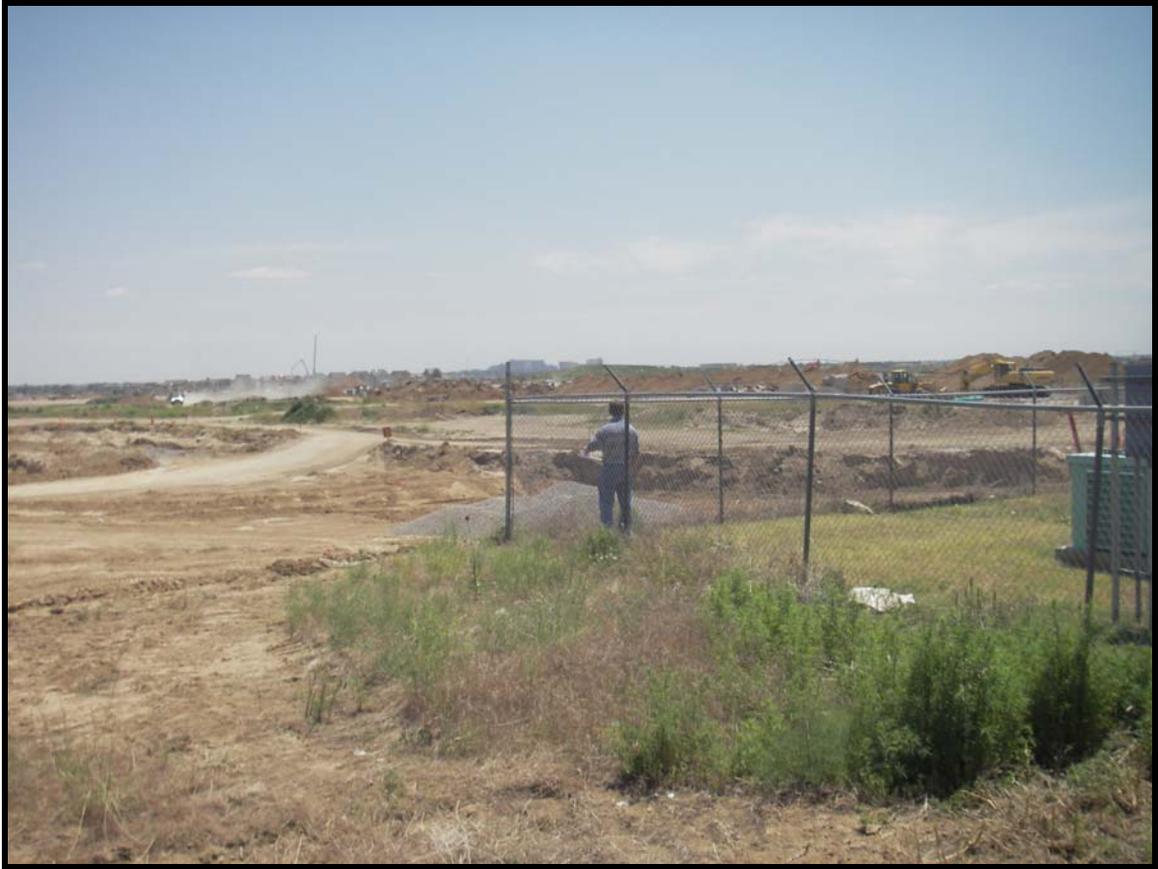
2

Looking south-east from the south-west corner corner of the Site.

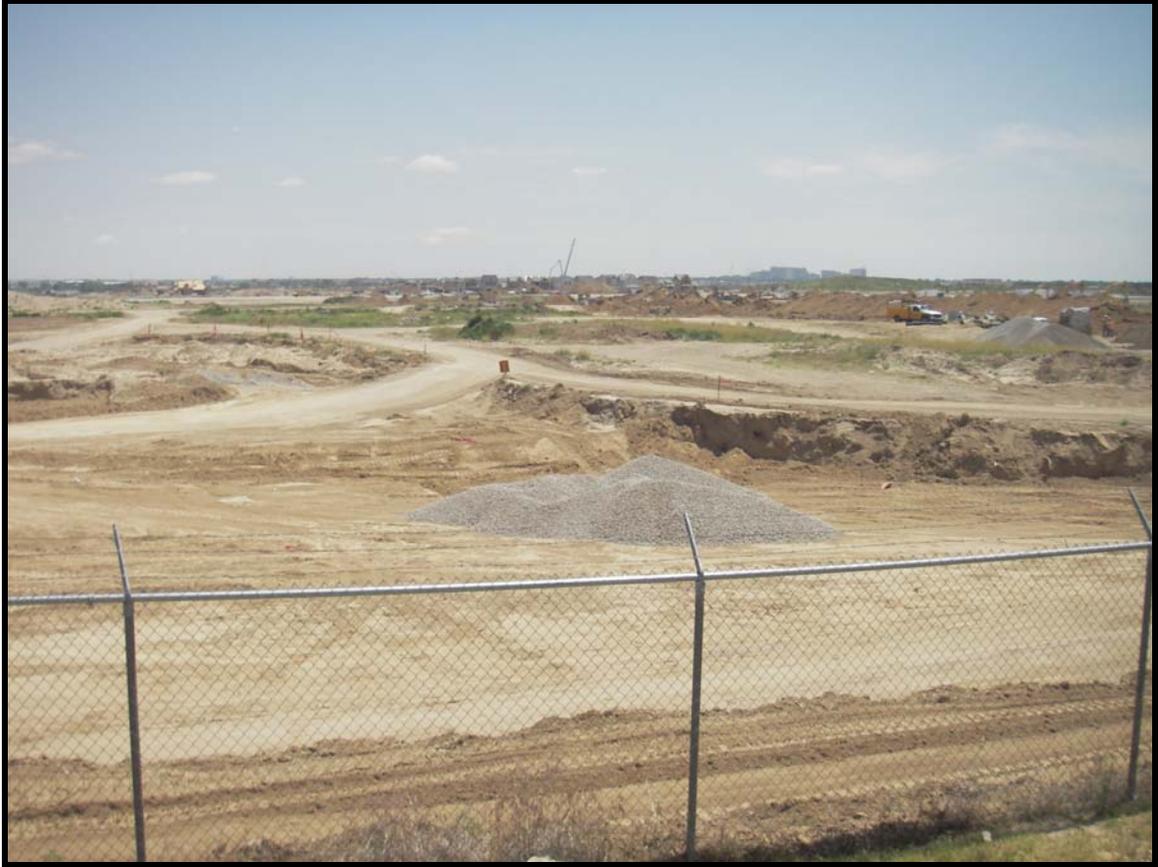
3

Looking east / south-east from the south-west corner of the Site.

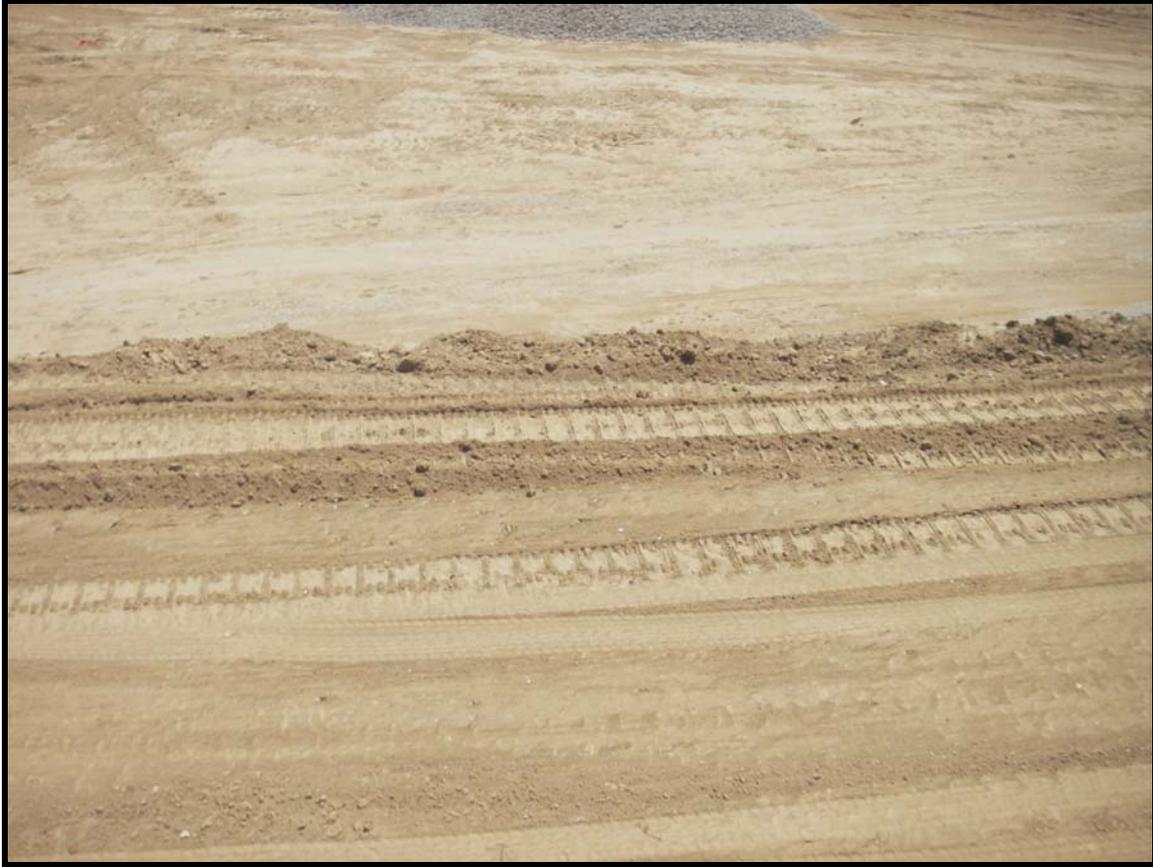
4

Looking to the east and down from the south-west corner of the site.

The ground nearest has been excavated to a depth of roughly 5 feet and the ground behind to roughly 13 feet.

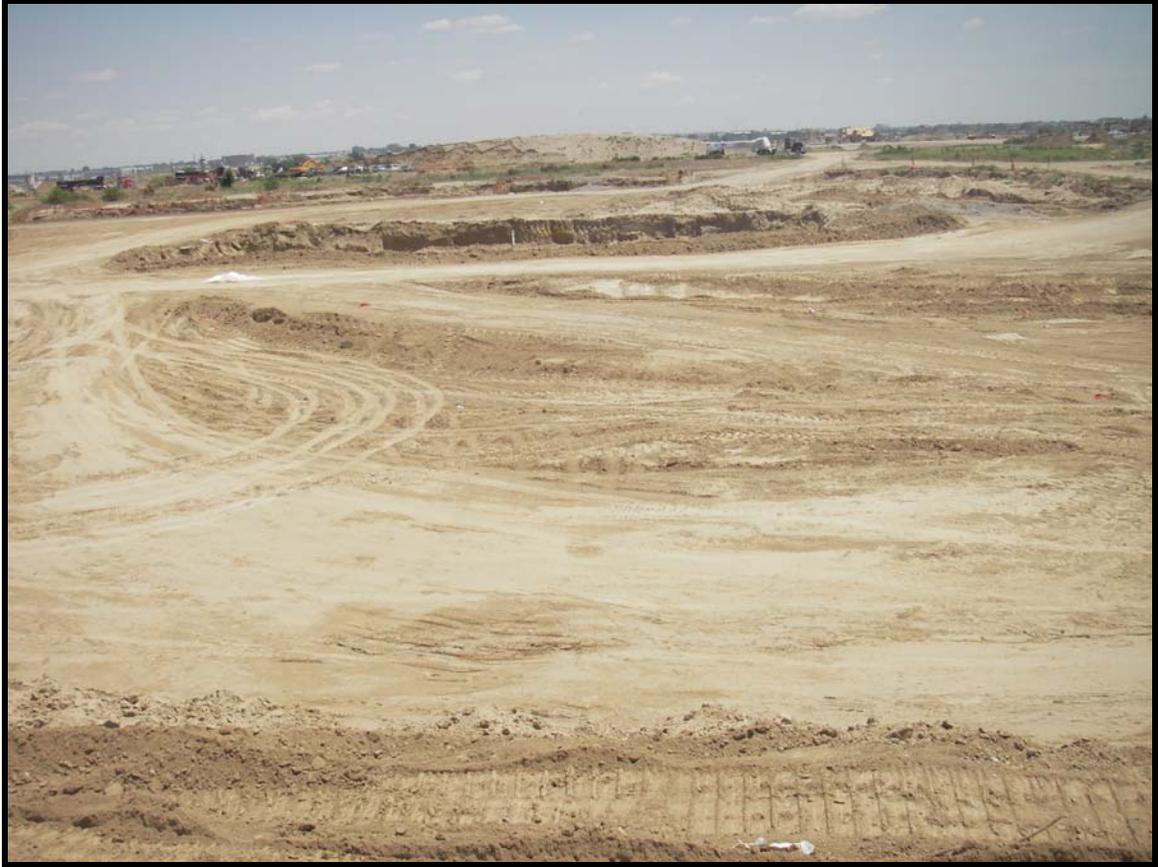
5

Looking to the east from the south-west corner of the Site.

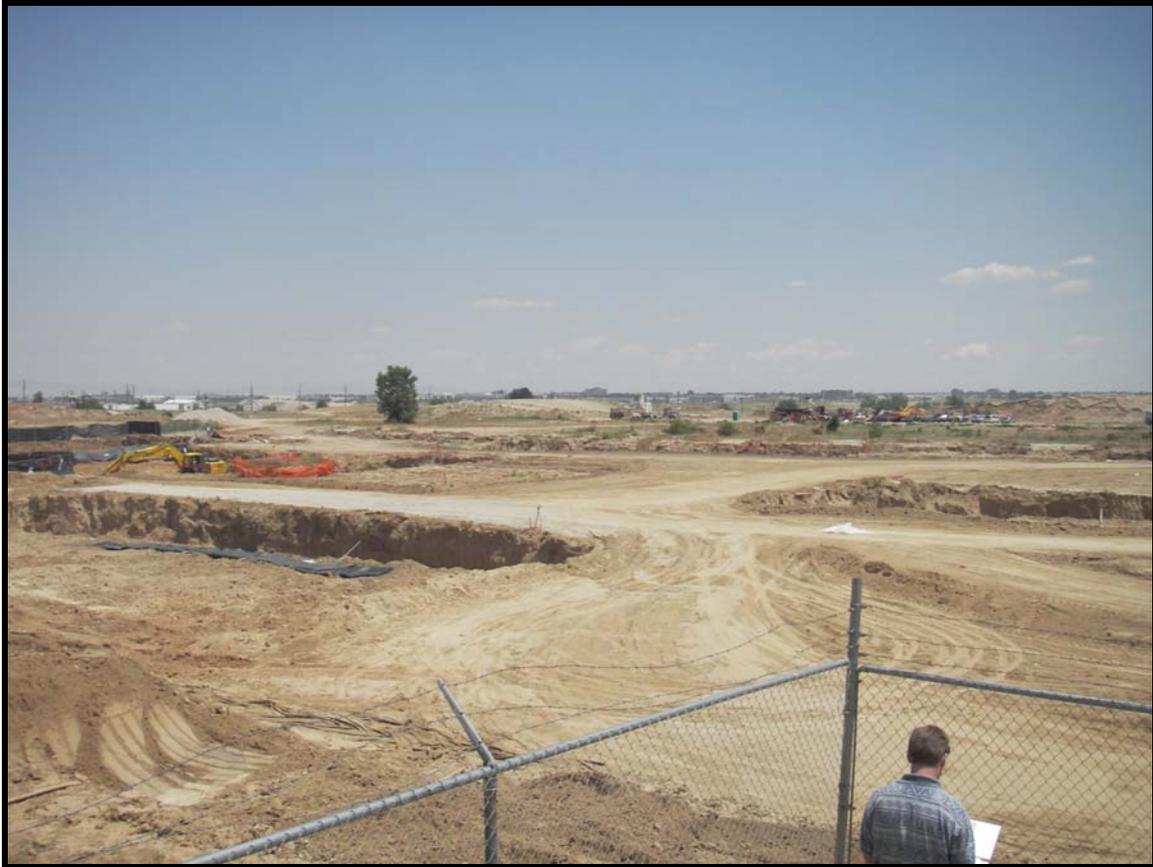
6

Looking to the north-east from the south-west corner of the Site.

There is a deep excavation to the right of the photograph.

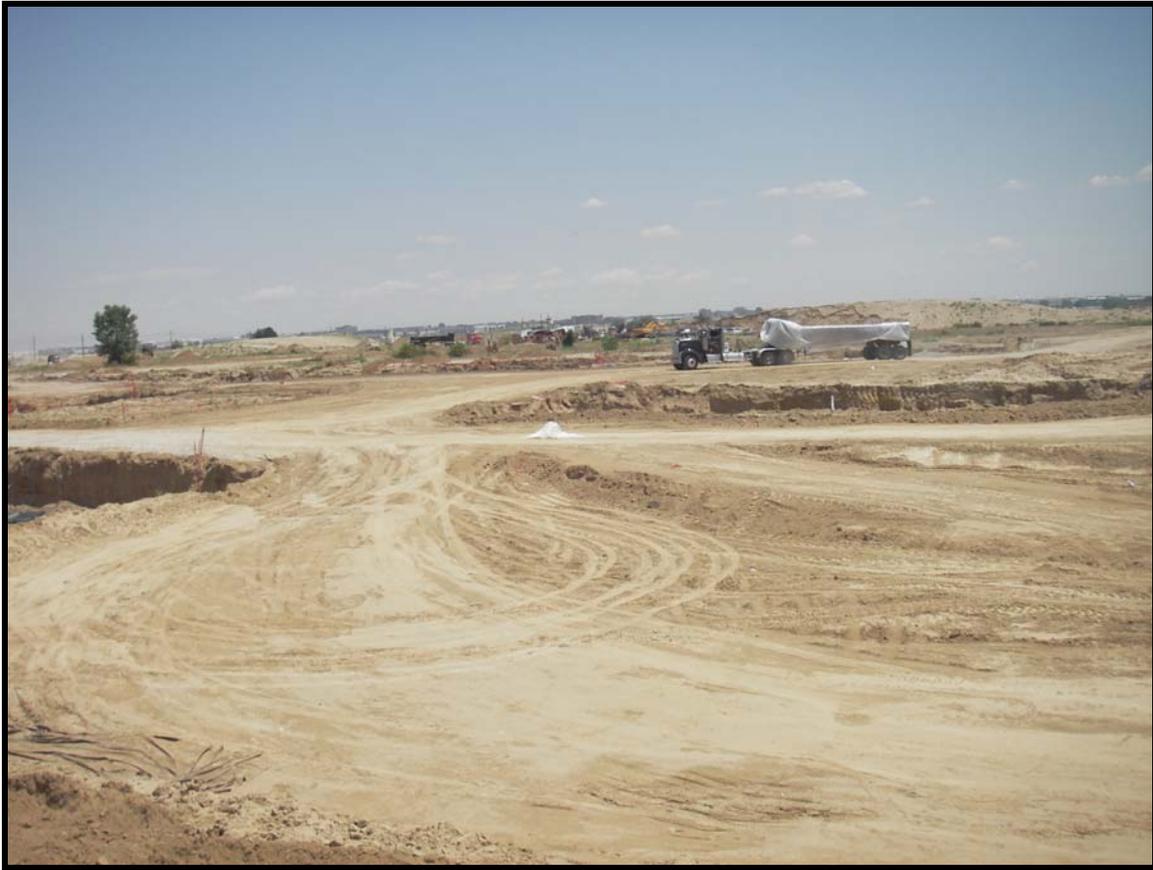
7

Looking to the west from the south-west boundary of the Site.

The exact location of the east boundary of the Site was difficult to determine. Our best estimate is the large soil pile beyond the tree.

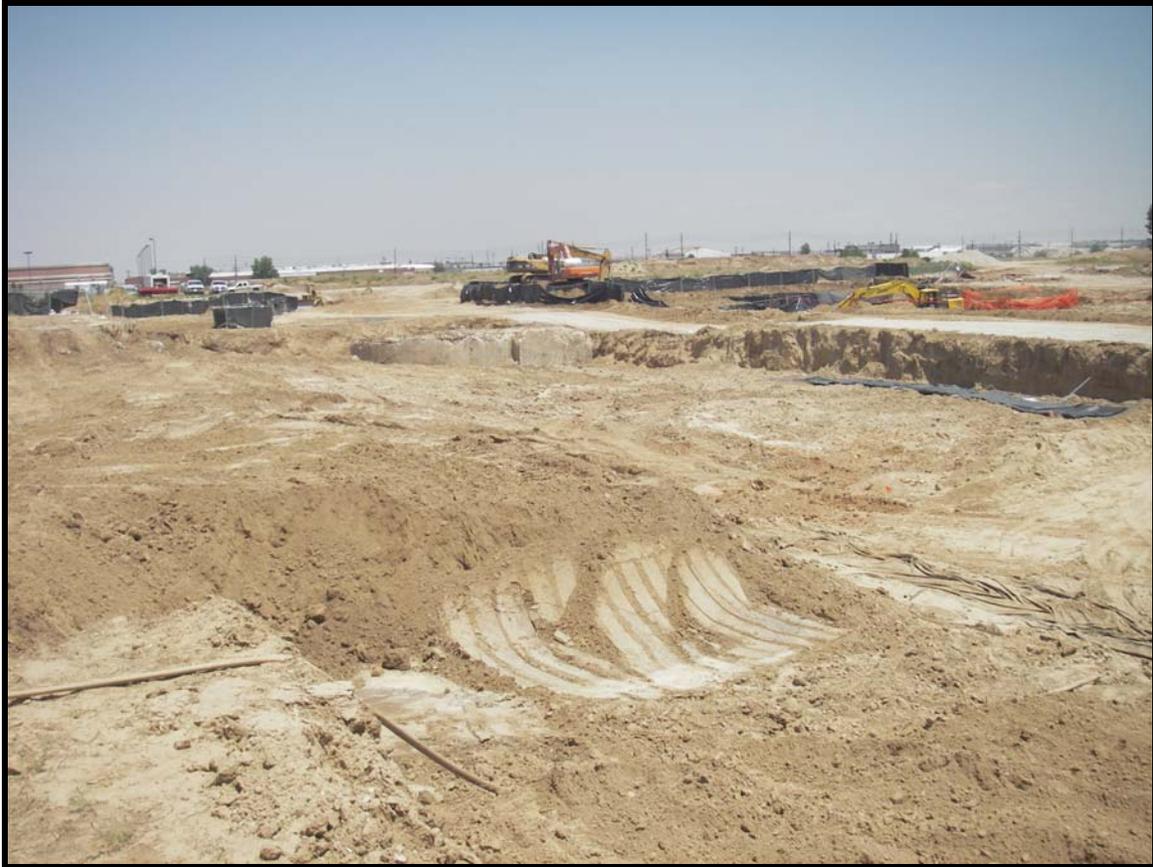
8

Looking to the north-east from the south-west corner of the Site.

While at the site we witnessed soil removal operations. Temporary black fencing bordered the areas of active excavation. Access tracks have been created for the trucks that remove asbestos containing material. The piping in the foreground appears to be used for temporary dust control during soil removal. A concrete structure can be seen in the middle of the photograph.

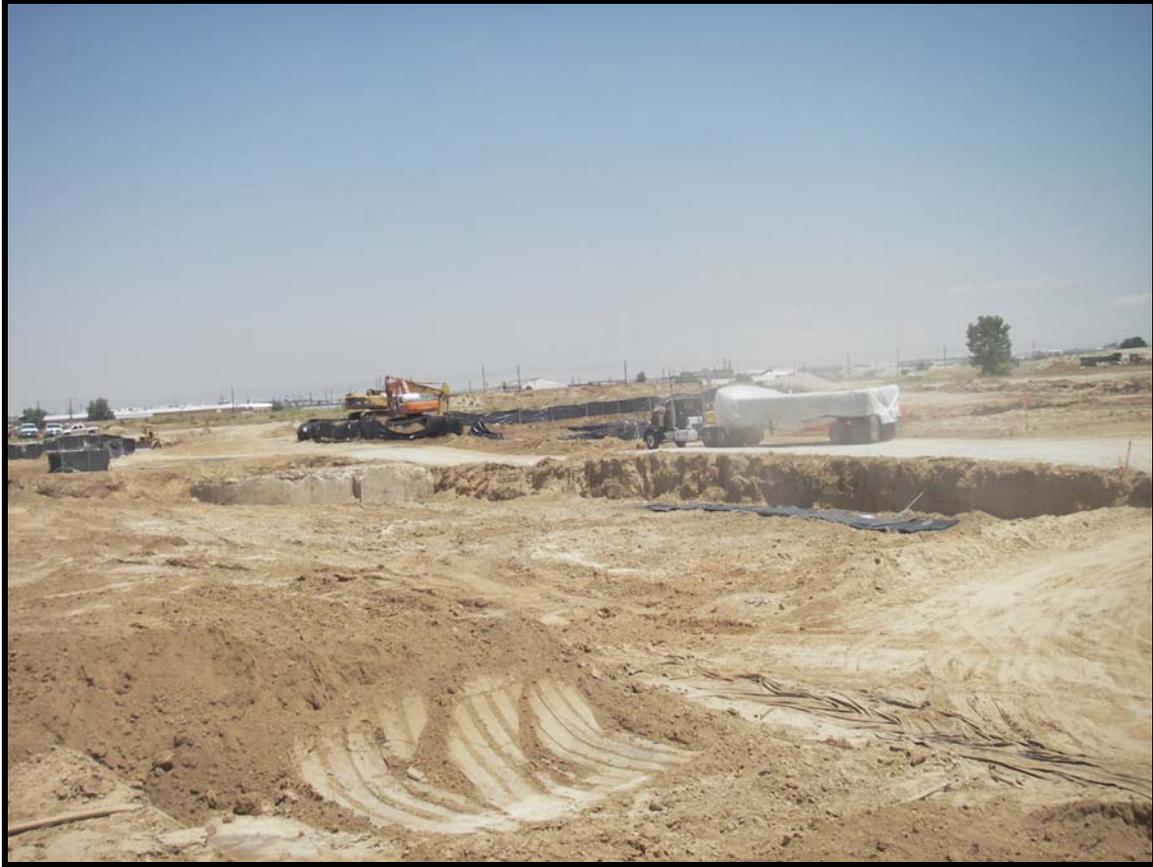
9

Looking to the north-east from the mid-west boundary of the Site.

Truck approaching the area of active excavation in the north-west corner of the property.

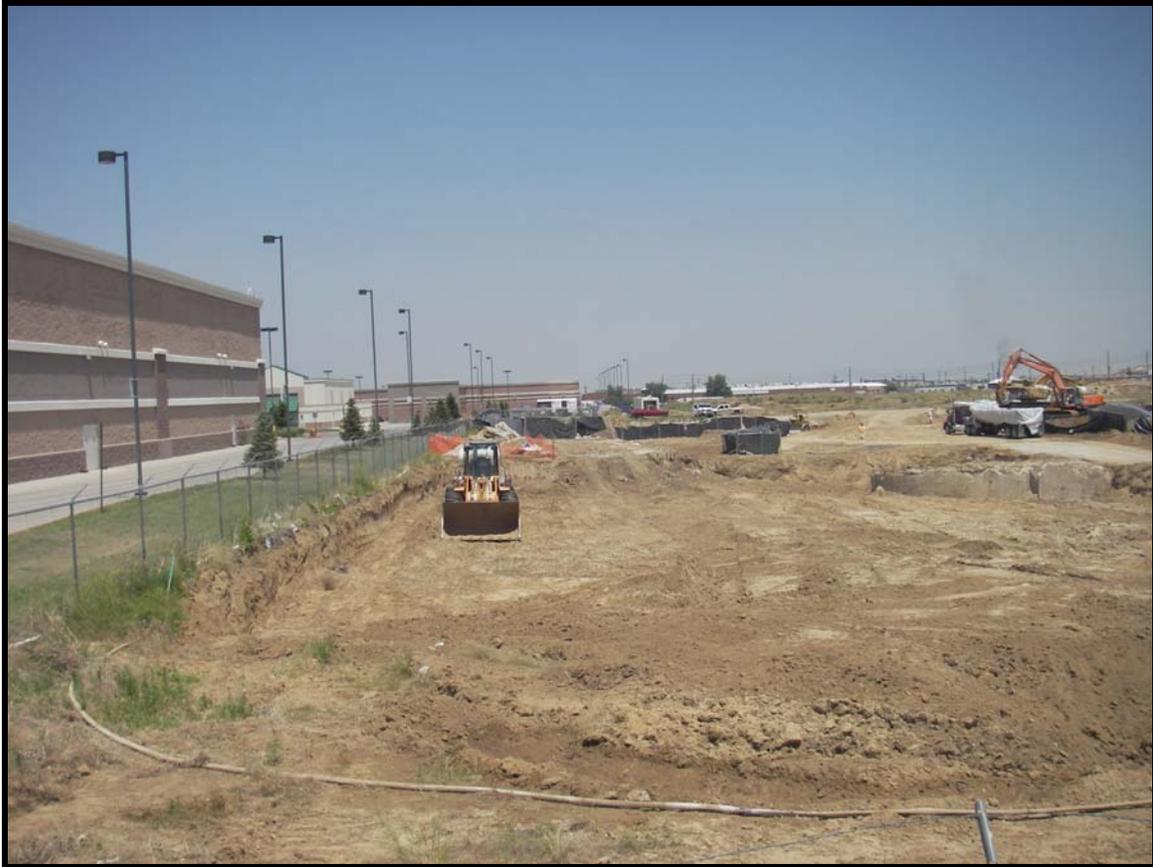
10

Looking to the north from the south- west corner of the Site.

The fence on the left is the property boundary. The piping in the foreground appears to be used for temporary dust control during soil removal.

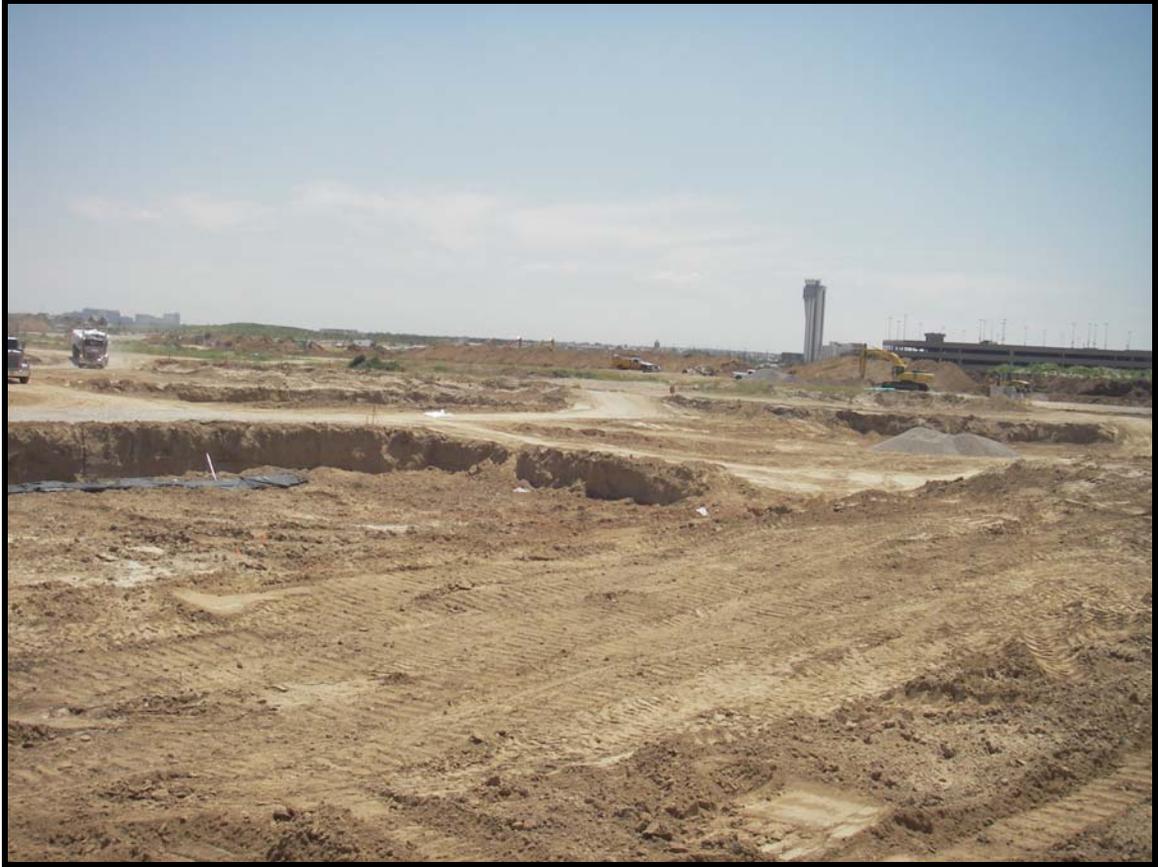
11

Looking to the south-east from the mid-west boundary of the Site.

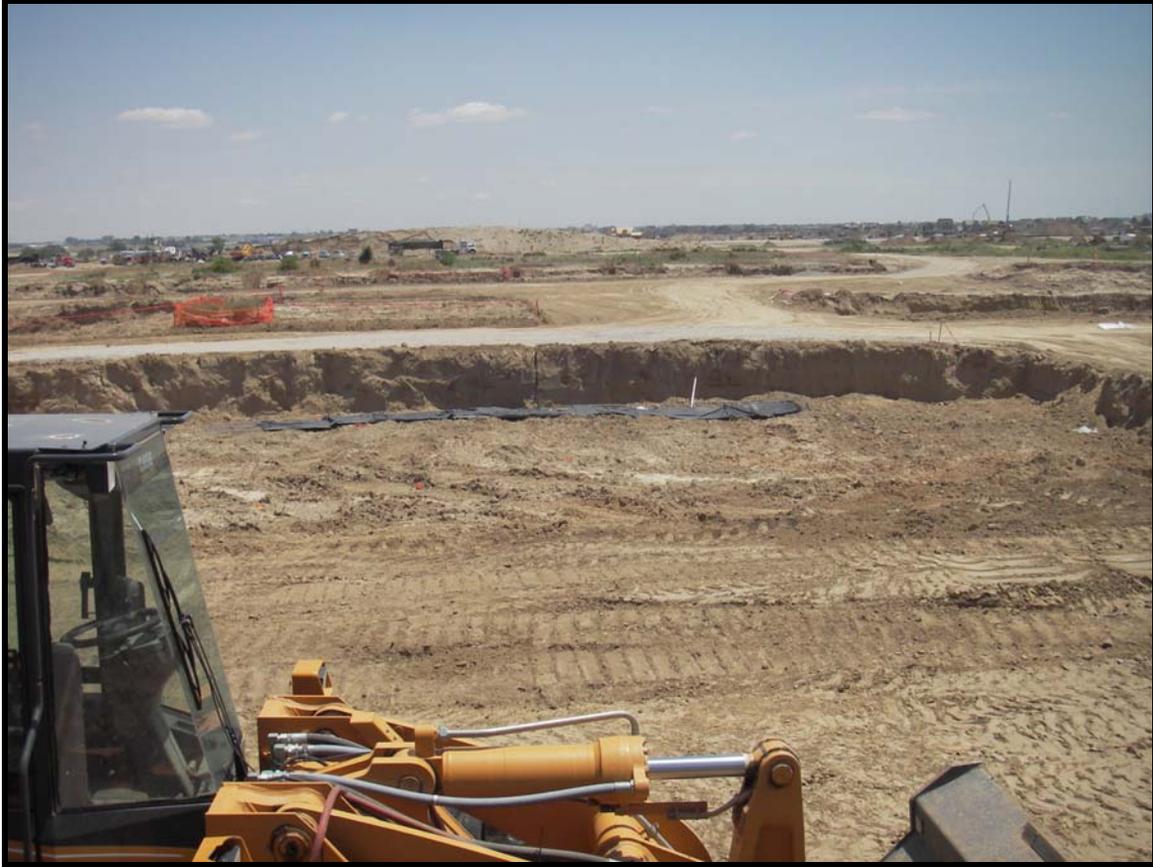
12

Looking to the east from the mid-west boundary of the Site.

The photograph shows the deeper excavations to a depth of approximately 13 feet.

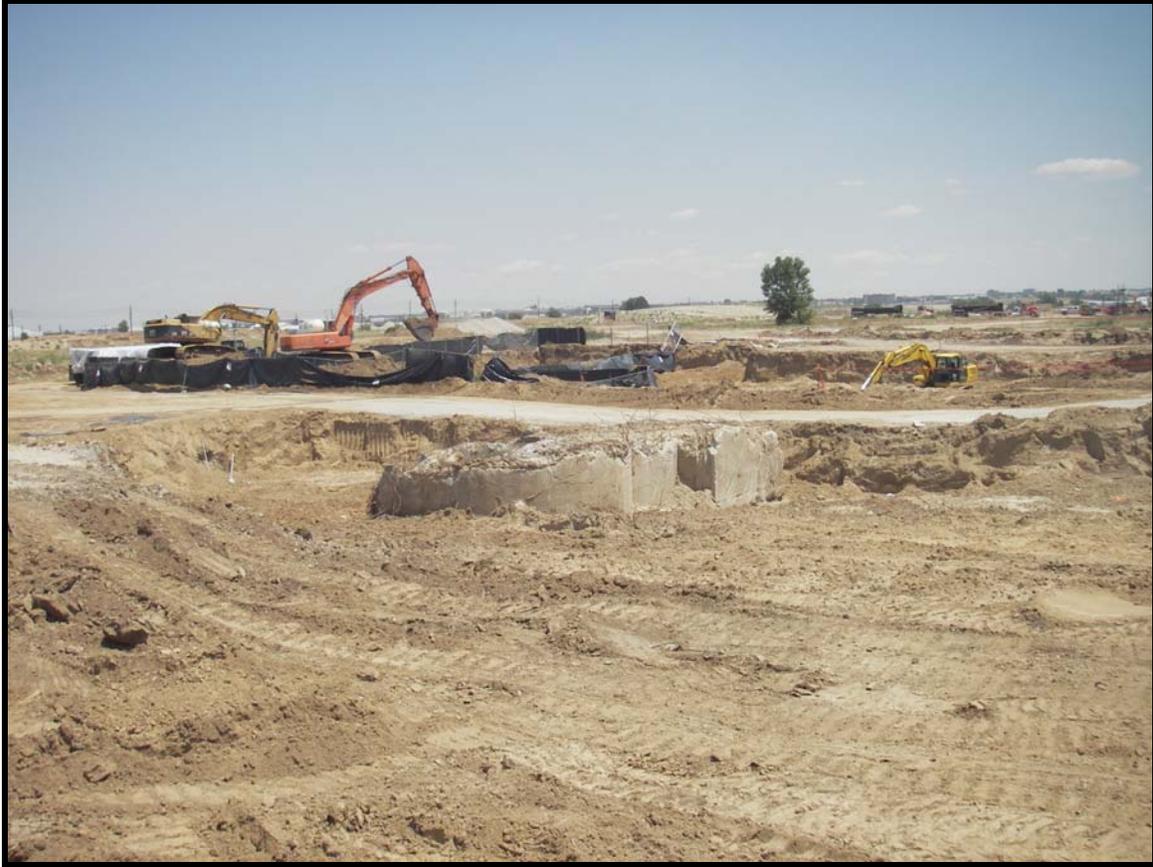
13

Looking to the east /north-east from the north-west corner of the Site.

The soil around the concrete structure has been excavated.

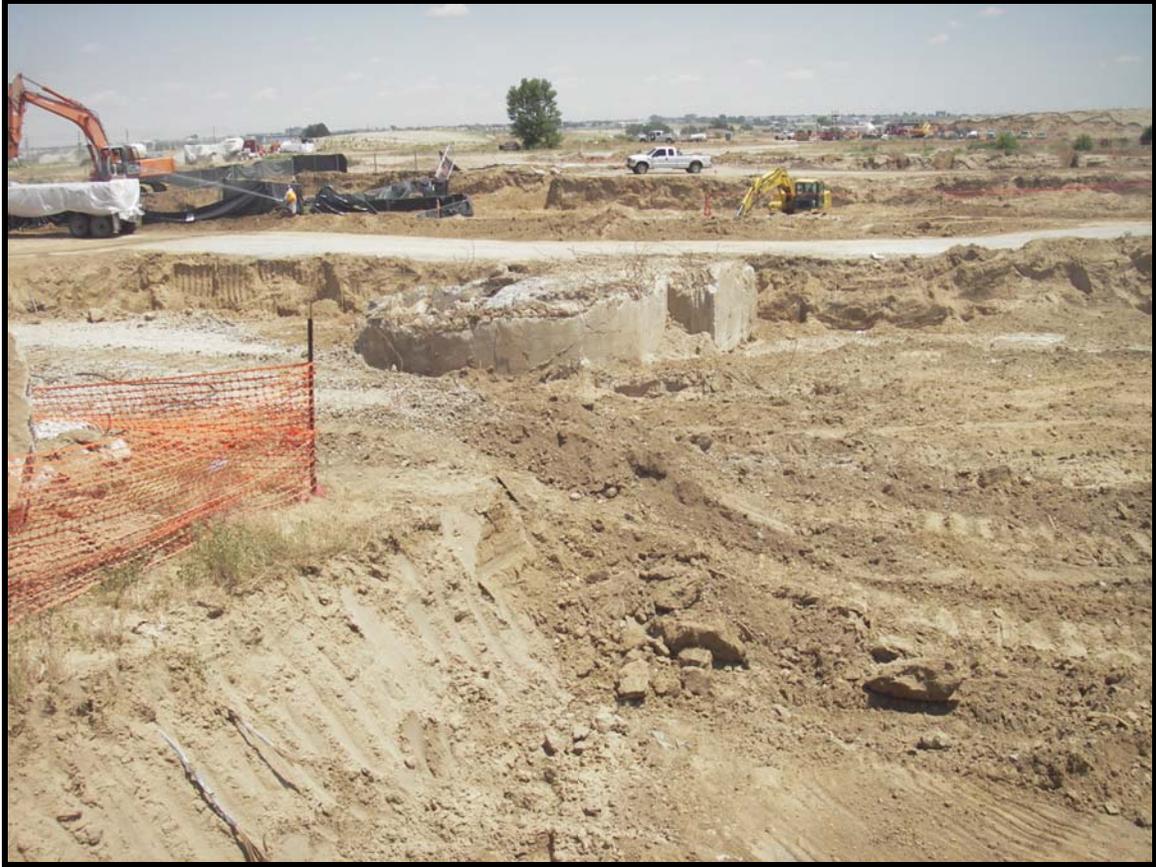
14

Looking to the east / north-east from the north-west corner of the Site.

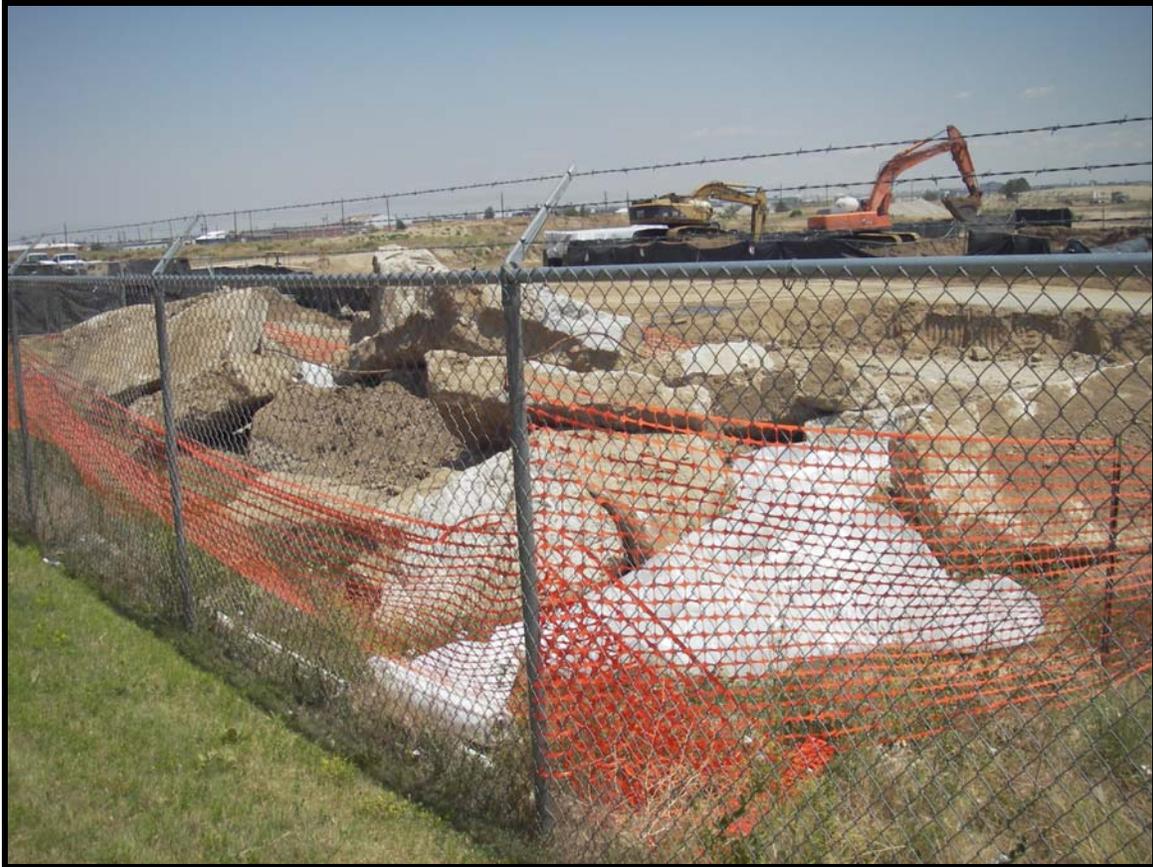
15

Looking to the north-east from the north-west corner of the Site.

The fence is the west boundary of the site. A pile of large concrete blocks is in the foreground.

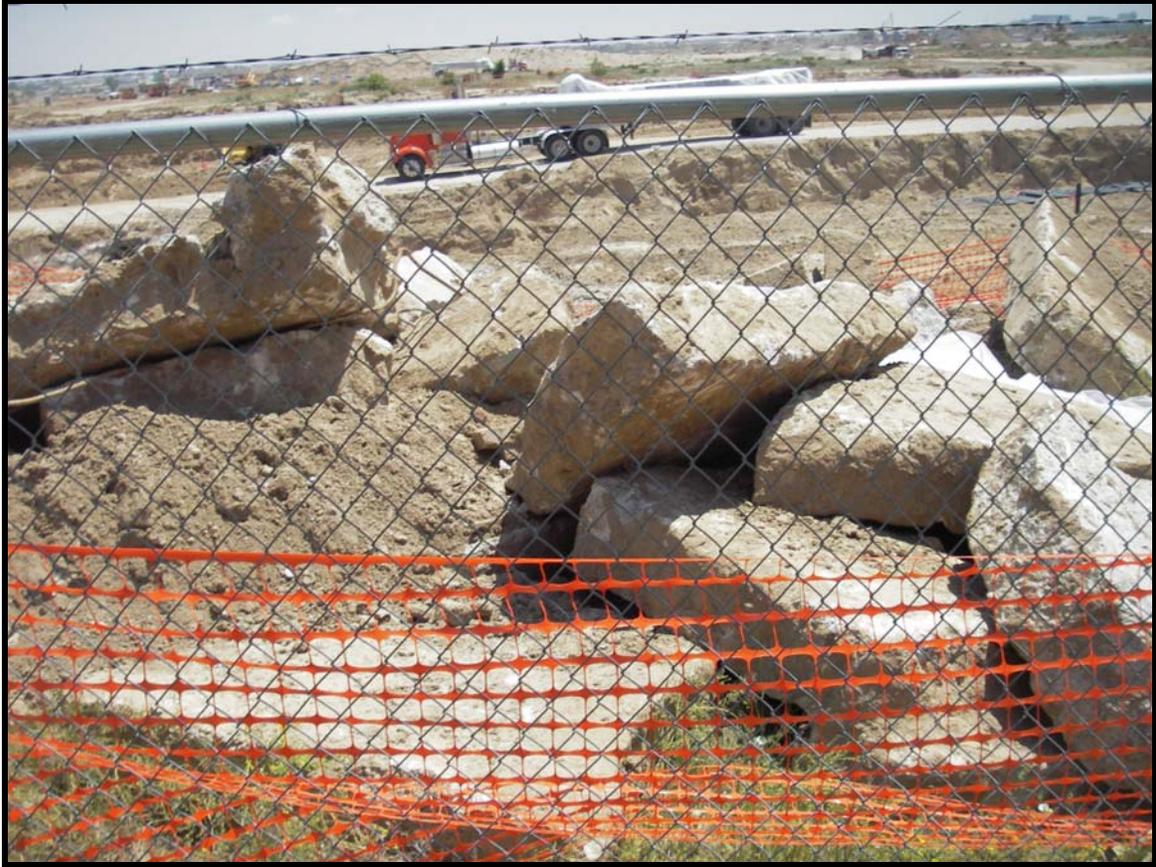
16

Looking to the east from the north-west corner of the Site.

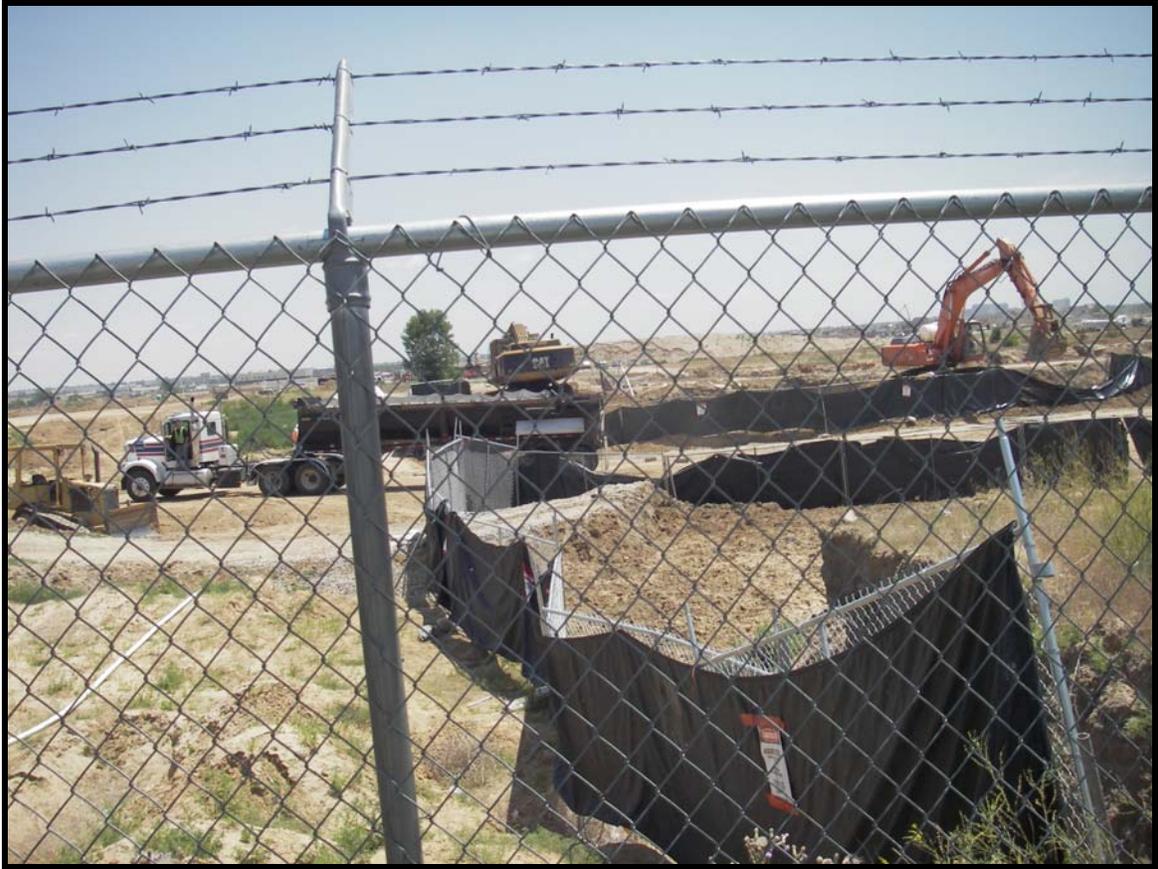
17

Looking to the east from the north-west corner of the Site.

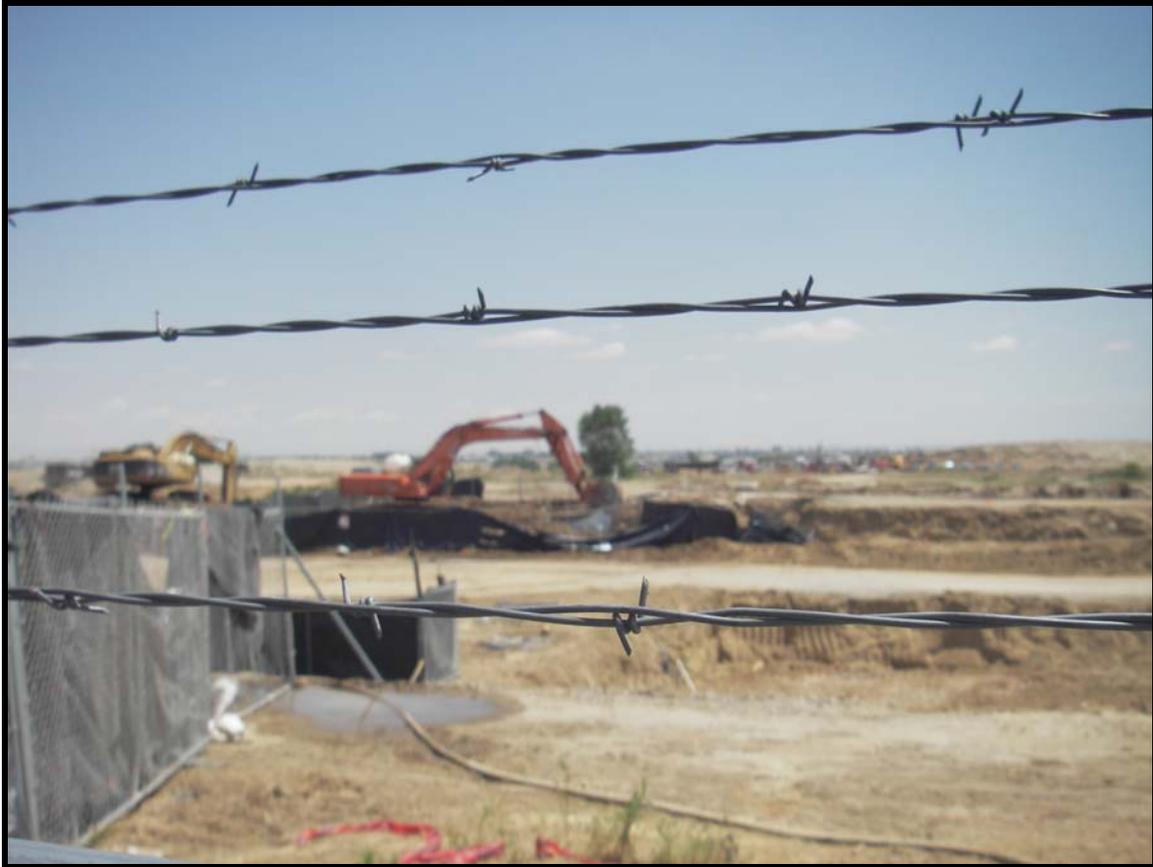
18
Looking to the east from the north-west corner of the Site.

The only evidence of water on the site was from temporary hose presumed connected to dust control.

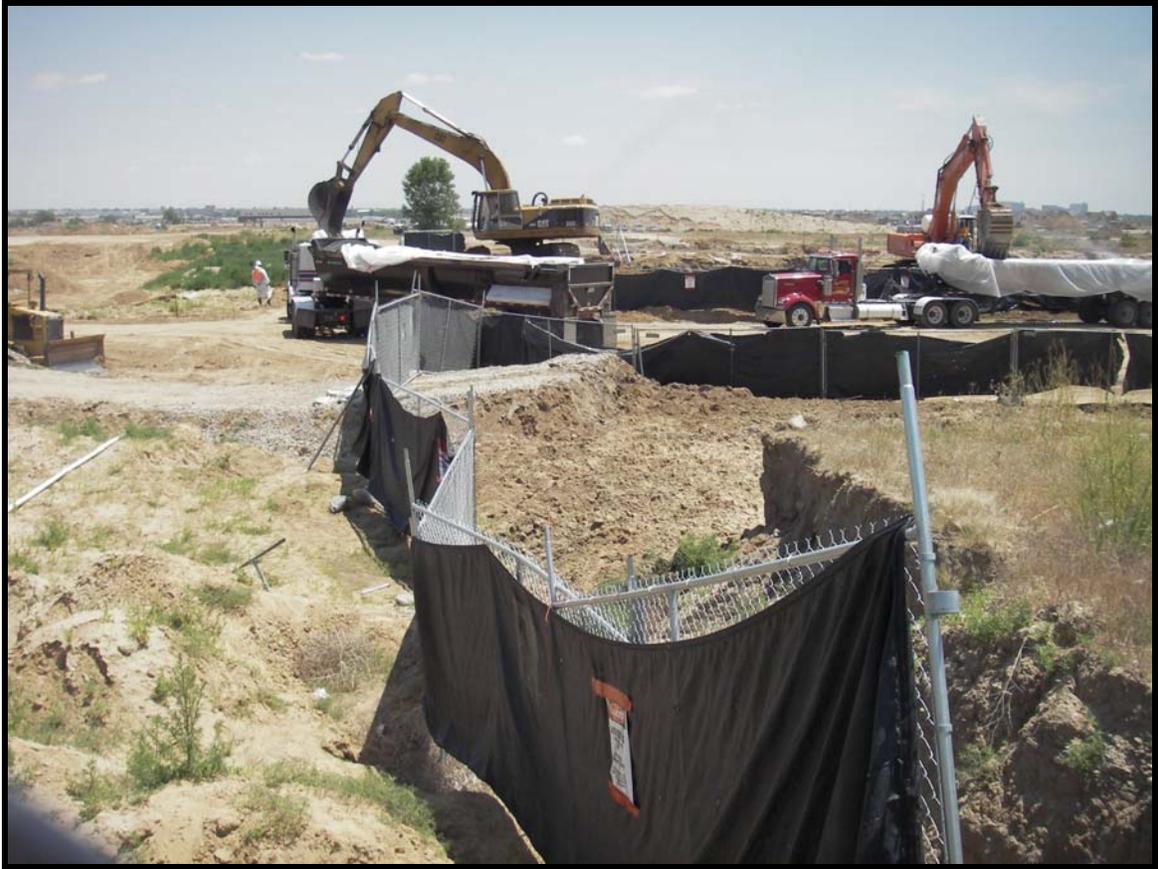
19

Looking to the east from the north-west corner of the Site.

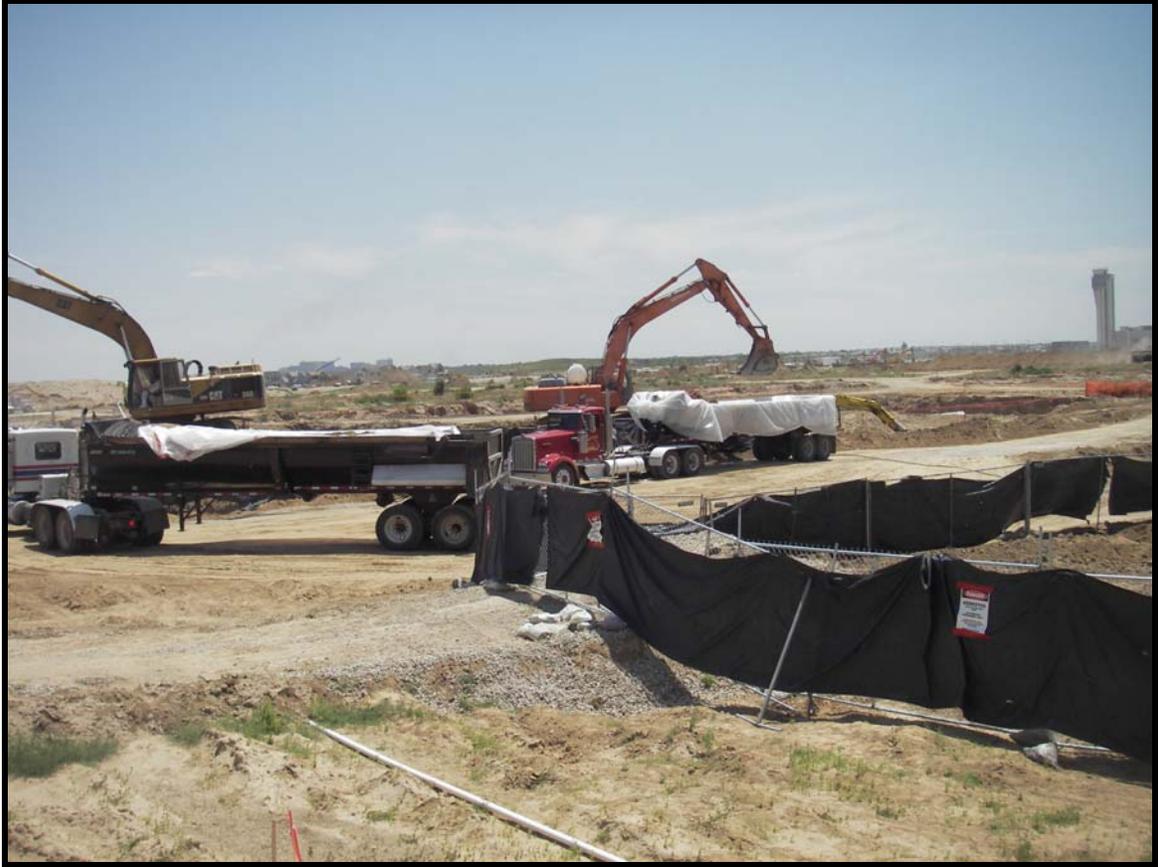
20

Looking to the south-east from the north-west corner of the Site.

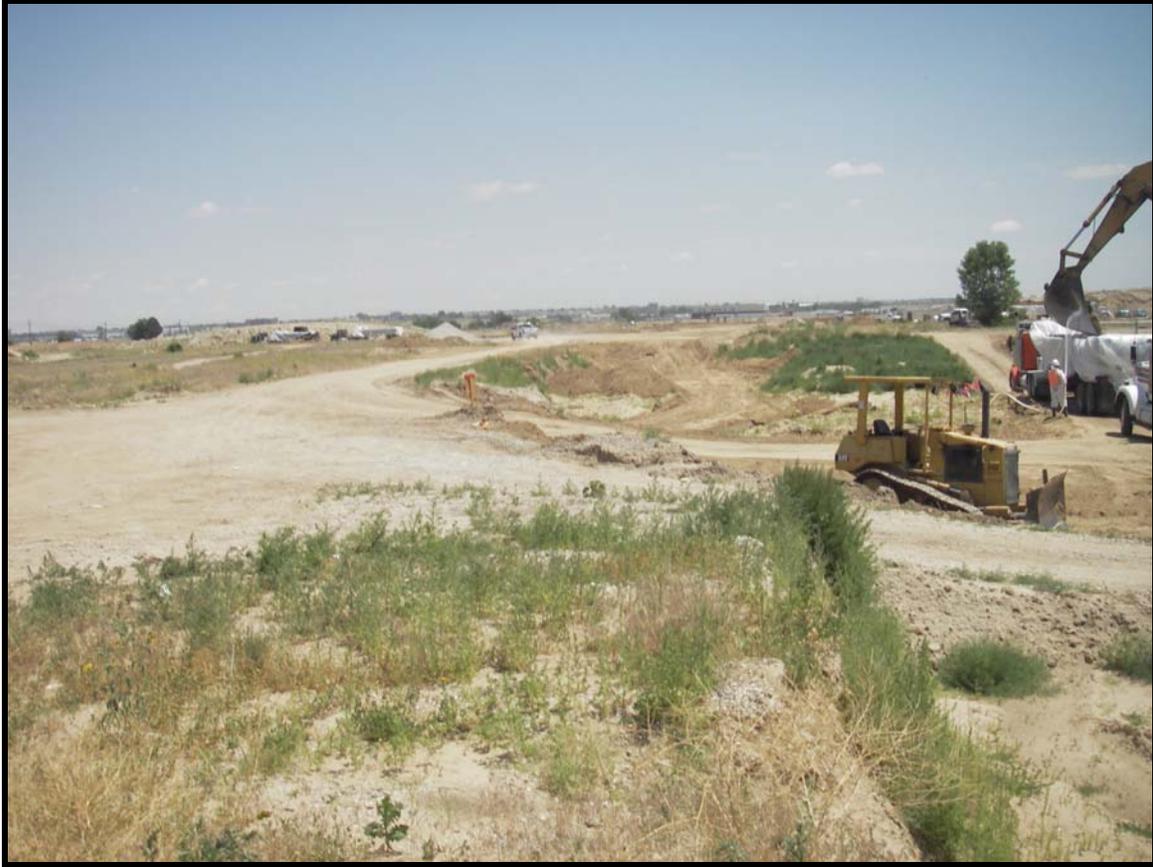
21

Looking to the east from the north-west corner of the Site.

The road on the left will become 36th Avenue, the northern boundary of the Site. The man in the photograph is hosing the air to keep dust down as the truck is loaded with excavated soil.

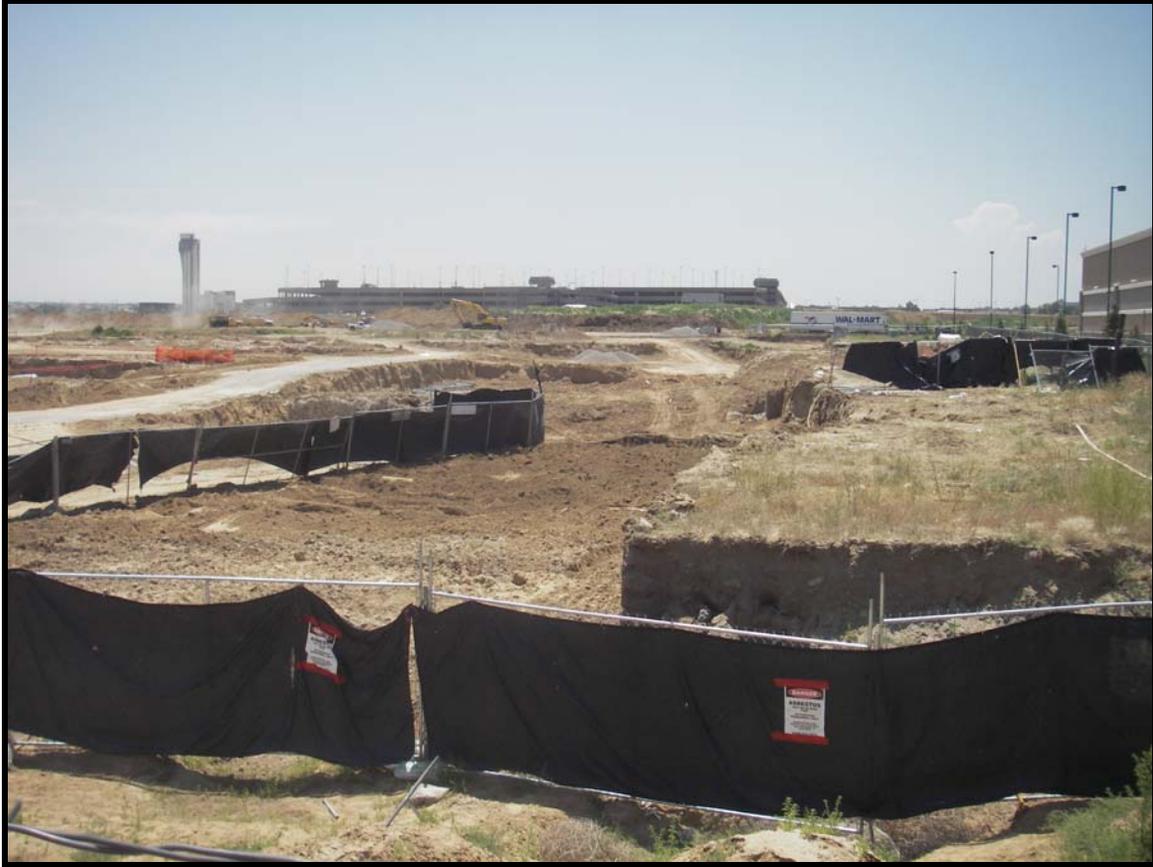
22

Looking to the south from the north-west corner of the Site.

The photograph shows the extent of soil excavation at the site.
